Examination report

Renovation, Management & Reuse

In Rotterdam, at Brede Hilledijk 95, Rijnhaven, stands the national monument Santos. Santos is a coffee warehouse built in 1901 and designed by architect J.P. Stok Wzn and J.J. Kanter. I have been asked to give this warehouse a new purpose and to create a management plan.

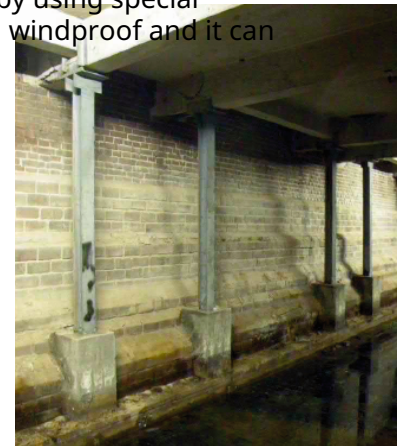
In the basement of the warehouse there are stamp constructions that the concrete floor beams supports. See image next to it.

The warehouse uses composite columns. The so-called Phoenix system: The iron columns consist of rolled quadrant profiles riveted together with flat iron strips. The quadrant profiles give the columns more strength. The beams can also connect to the columns.
